## Lineaments Analysis of Tabnak Field Using LANDSAT Images

Bahram Habibnia<sup>1,\*</sup>, Seyyed Mahmood Ghodosi Nejad<sup>1</sup>, Samira Emadi<sup>1</sup>

1- Abadan Faculty of Petroleum Engineering, Petroleum University of Technology, Abadan, Iran.

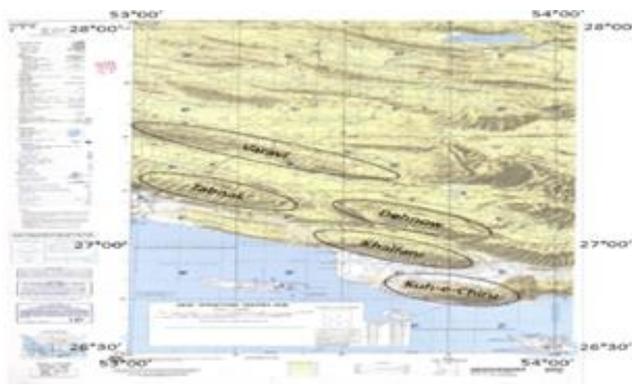
Figure 1) The topographic map and location of Tabnak field

beds of blackish gray, grayish-green and massive shale. Some limestone is much more argillaceous (Guang *et al.*, 2006). The topographic and geological map and location of Tabnak field are shown in Figures 1 and 2. Lineaments are natural simple or composite-pattern linear or curvilinear features discernible on the Earth's surface. In the geologic sense, these features may depict crustal structure or may represent a zone of structural weakness. These originate mainly from strains that arise from stress concentrations around flaws, ↓ heterogeneities, and physical discontinuities,

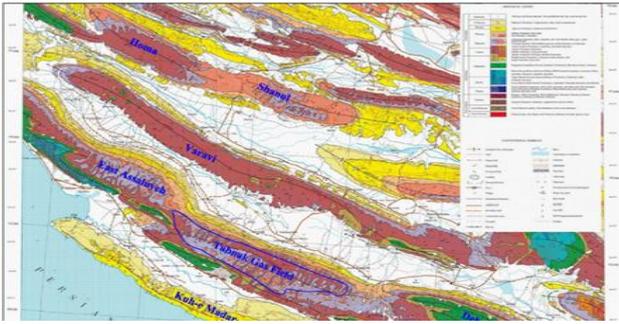
Figure 2) Geological map and Location of Tabnak field

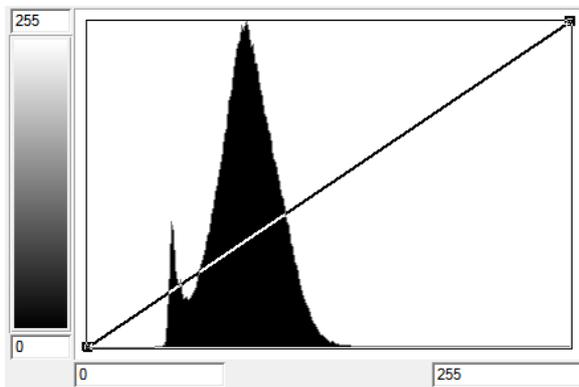
Figure 3) Histogram of band#1 before histogram modification.

pixels in each band have been limited to a smaller range. These ranges are between 40 and 134 for band#1, 15 and 187 for band#3, 3 and 165 for band#7. Therefore, histogram modification was performed to improve the image quality and more marking of lineaments. In this way, the dark points of image will be darker and the bright points of image will be brighter and image quality increases. The histograms of bands#1, 3 and 7 before and after histogram modification are shown in the Figures 3 to 8. The Figures 9 and 10 show the satellite image of Tabnak gas field before and after histogram modification.

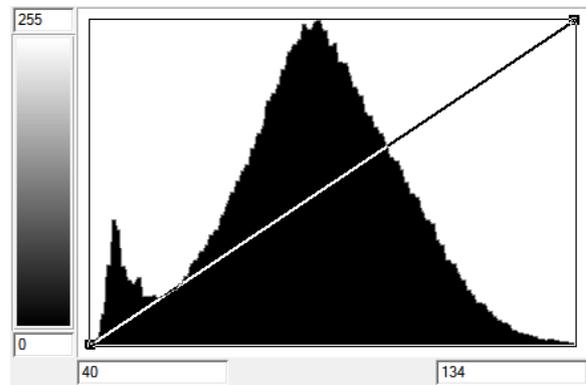
Figure 4) Histogram of band#1 after histogram modification.

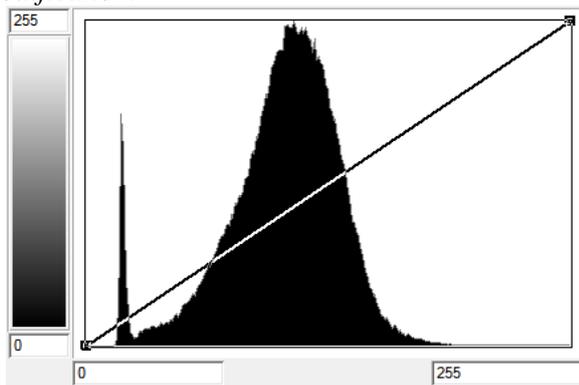
Figure 5) Histogram of band#3 before histogram modification.

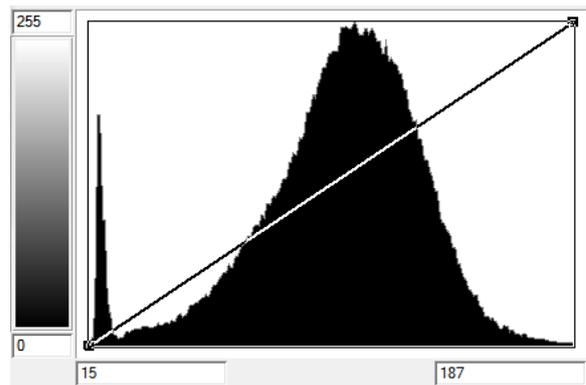
Figure 6) Histogram of band#3 after histogram modification.

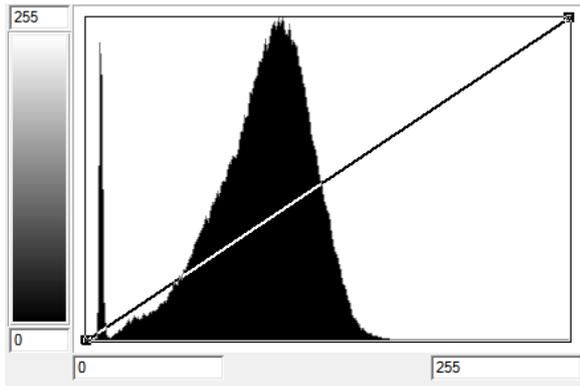
Figure 7) Histogram of band#7 before histogram modification.

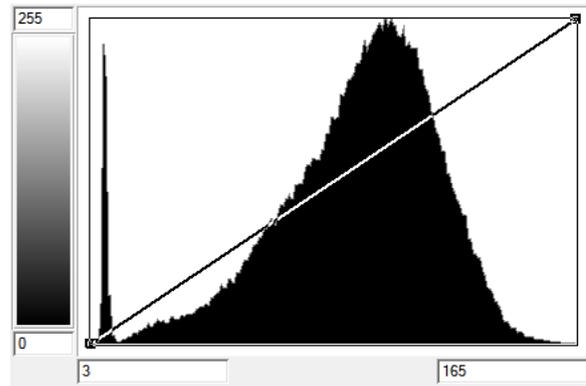
Figure 8) Histogram of band#7 after histogram modification.

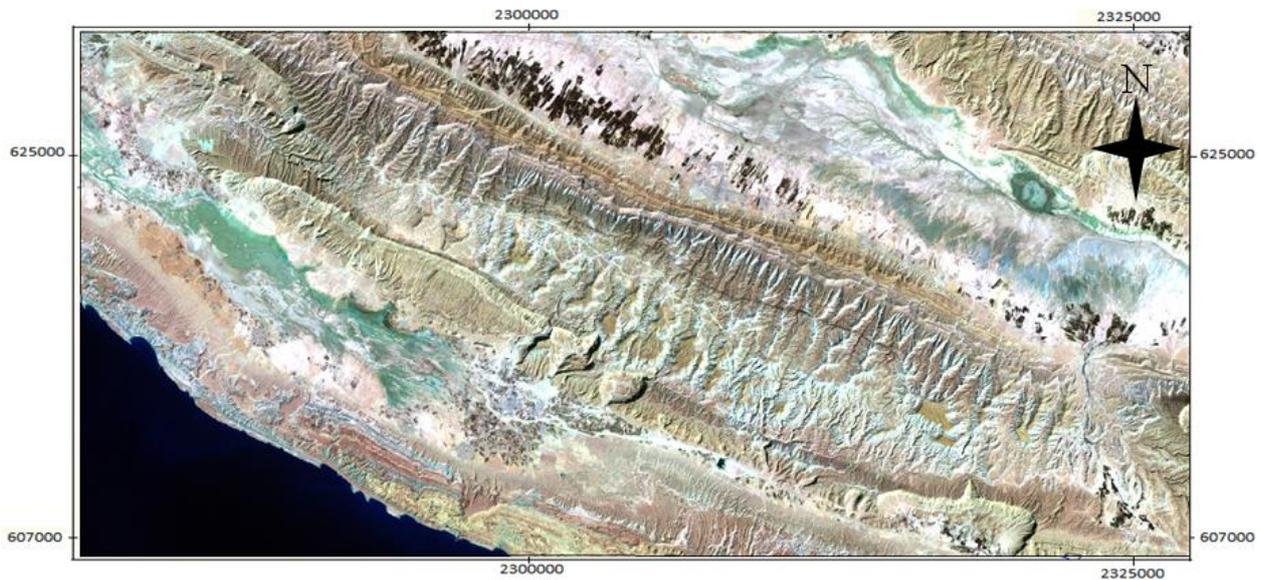
Figure 9) Satellite image of field before histogram modification.

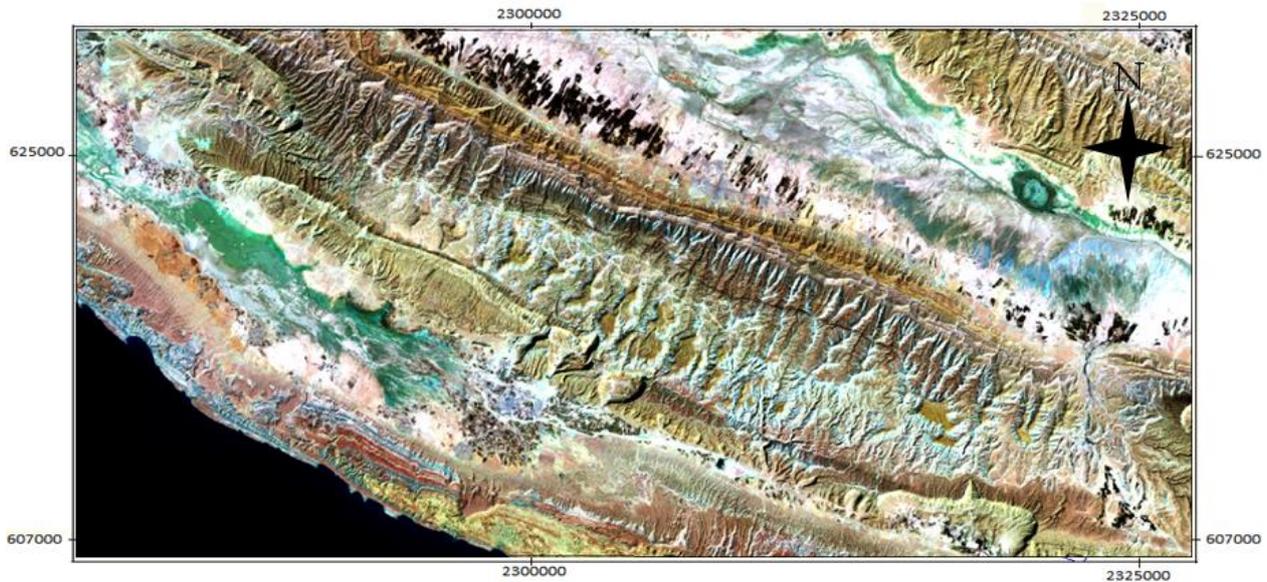
Figure 10) Satellite image of field after histogram modification.

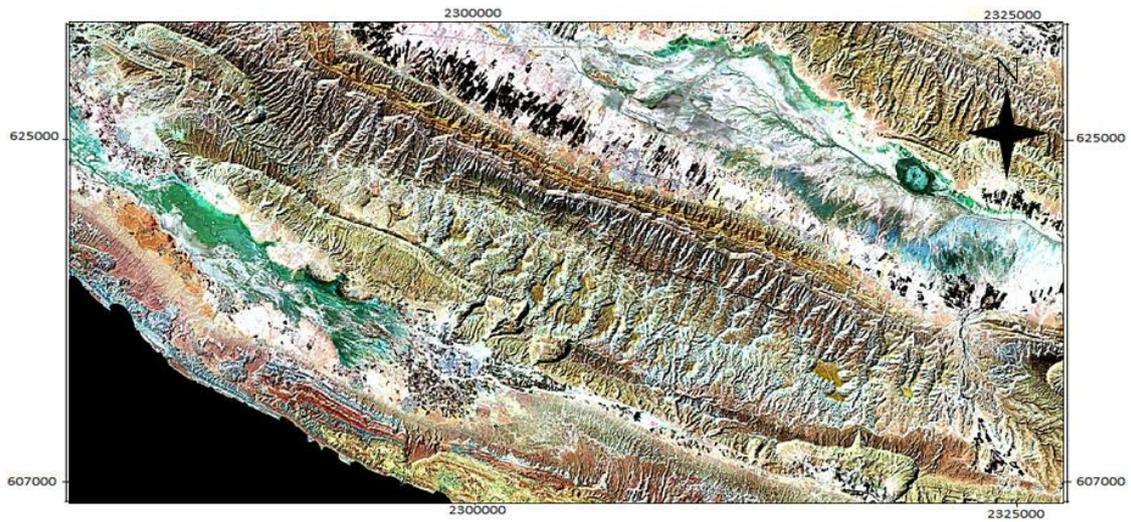
After histogram modification, for detection and extraction of lineaments in the study area a filter was used. This filter is a matrix which has 25 elements. Figure 11 depicts the matrix of filter. This filter moves on the satellite image and convolution is done between the filter and the image. Figure 12 shows satellite image after applying the filter. As can be seen in the figure, lineaments are more apparent after filtering.

Figure 12) Satellite image after applying the filter.

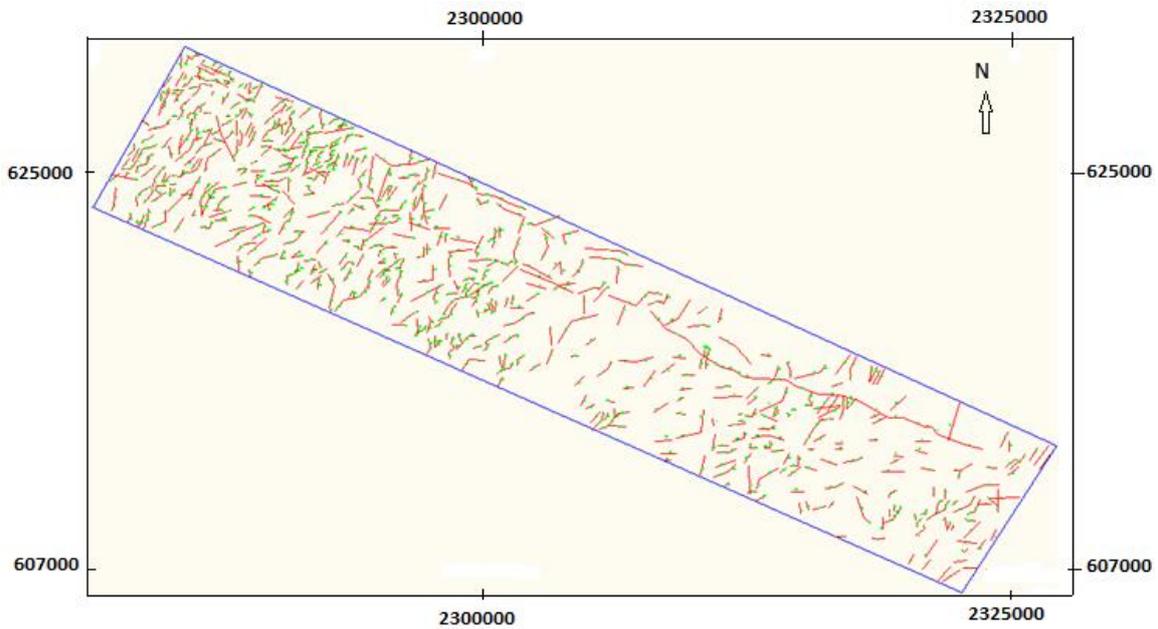
After the processing, 847 lineaments were extracted in the region. As can be seen in the Figure 13, the density of lineaments in north-western part of the field is higher than other parts.

Figure 13) Lineaments Map.

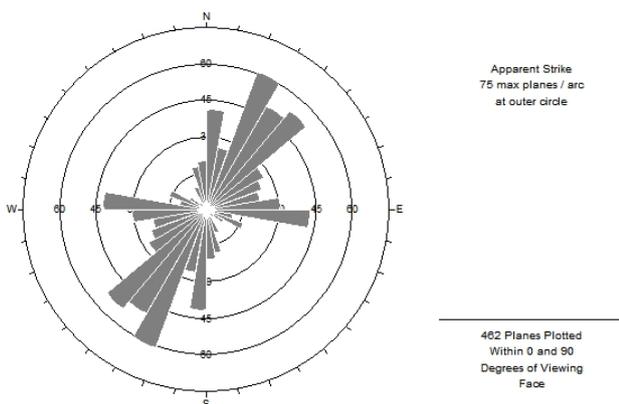
The Figure 14 depicts rosette plot of lineaments in the northwestern part of the field. As the rosette plot above shows in this part of the field, lineaments have strikes in different directions, but they are dominantly oriented in the NE-SW direction. Three lineament sets are dominant in this part and they have strikes in N20°E to N50°E directions.

Figure 14) Rosette plot for strike of lineaments in the NW (North-West) field.

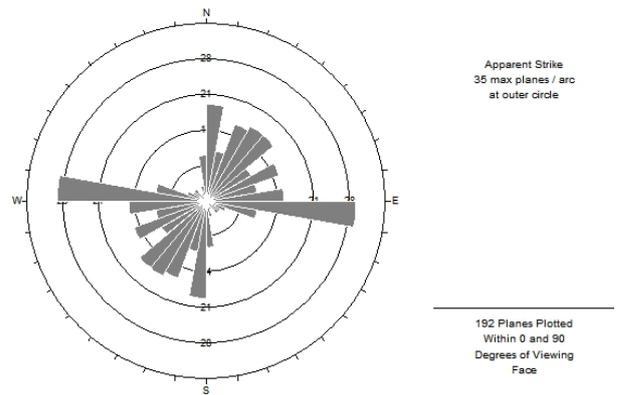
The rosette plot of lineaments in the southeastern part of the field is shown in Figure 15. The rosette diagram shows in this part of the field, lineaments have strikes in different directions. The orientation of lineaments is dominantly NE-SW. Two lineament sets are dominant in this part and they have strikes in N80°-90°W and N0°-10°E directions.

Figure 15) Rosette plot for strike of lineaments in the SE (South-East) field.

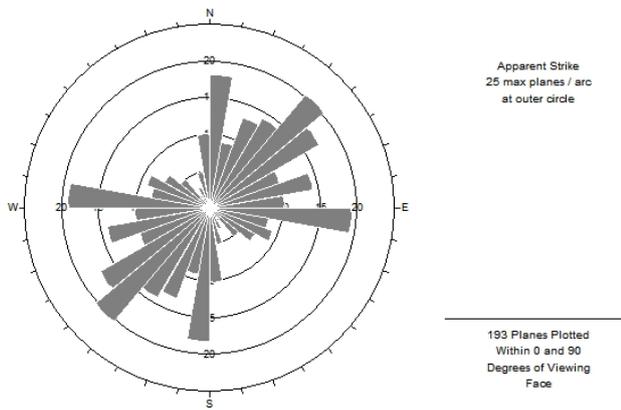
The Figure 16 shows rosette plot of lineaments in the central part of the field. The rosette plot shows lineaments have strikes in different directions. The dominant orientation of lineaments is ENE-WSW in this part of the field. Three lineament sets are dominant and they have strikes in N80°-90°W, N40°-50°E and N0°-10°E directions.

Figure 16) Rosette Diagram for strike of lineaments in central part of the field.

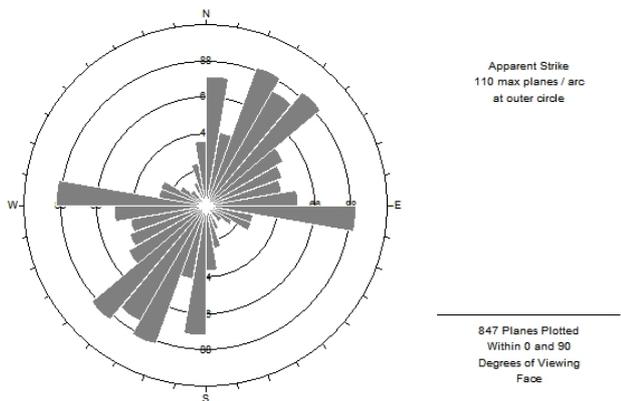
Figure 17 depicts rosette plot of lineaments in total of the field. The rosette plot shows lineaments have strikes in different directions. The dominant orientation of lineaments is NE-SW. Three lineament sets are dominant and they have strikes in N80°-90° W, N40°-50°E and N20°-30°E directions.

Figure 17) Rosette plot for strike of lineaments in total of the field.

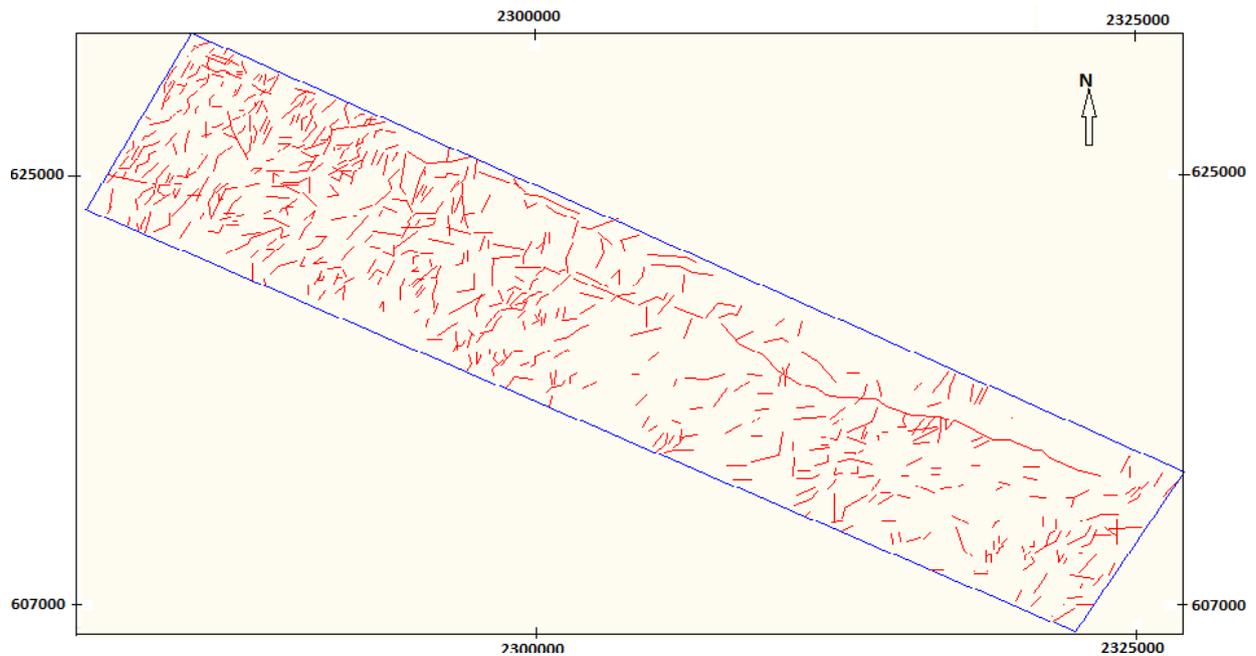
Extracted lineaments are not just related to fractures and faults, but some are related to water ways, roads and etc. Since only the lineaments that are related to fractures and faults are important and so other lineaments should be removed from lineament map. For this purpose, topographic and geologic maps of the study area are used to remove lineaments that related to roads, water ways and etc. Figure 18 shows the lineaments map after removal of artificial lineaments. As can be seen a significant number of lineaments are artificial and have been removed.

Figure 18 Lineaments map after removal of artificial lineaments.

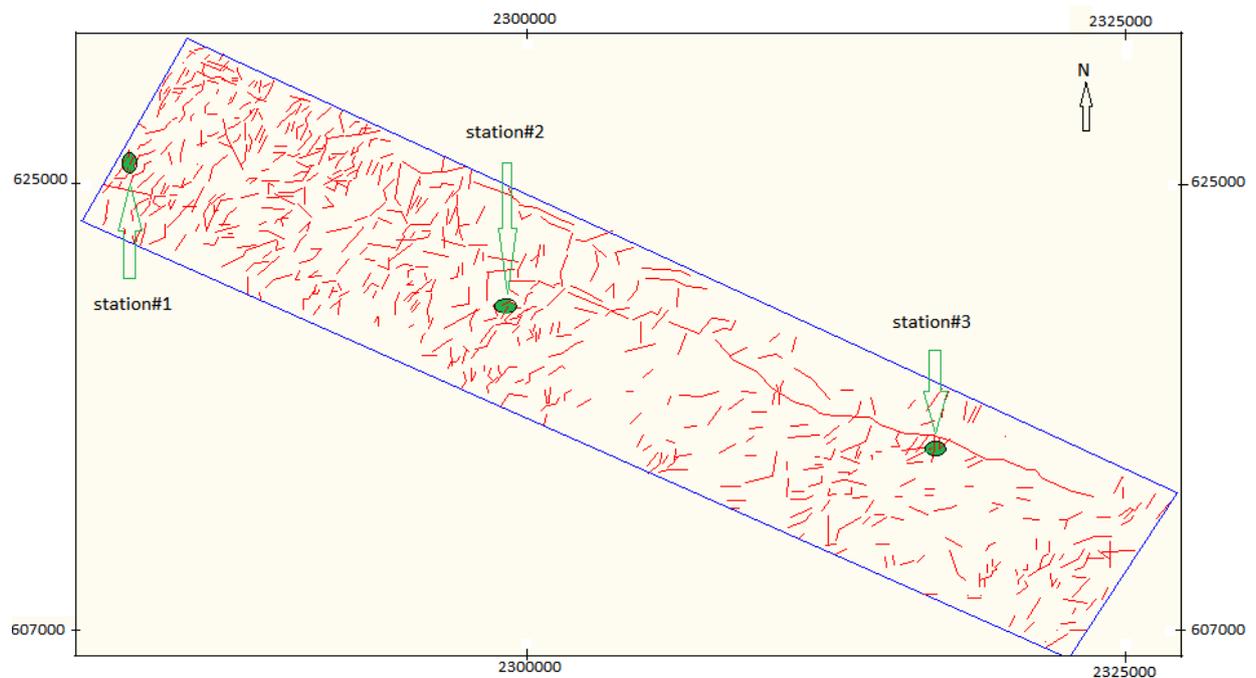
Finally, to verify the extracted lineaments orientation, field studies were conducted and strike and dip of the lineaments were measured at three stations by compass. Figure 19 shows the location of stations.

Figure 19 Location of stations.

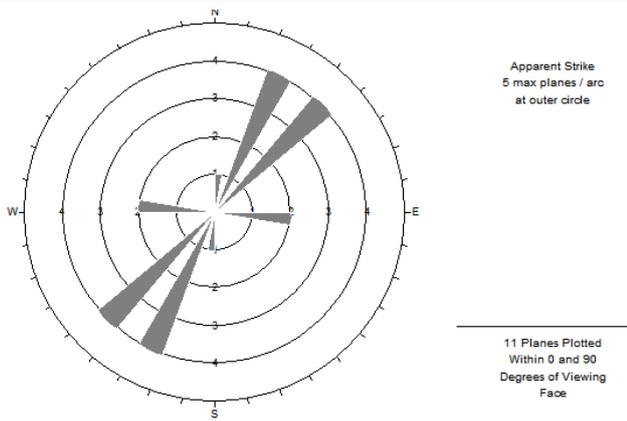
This station has coordinate E: 2283150 and N: 625920 that N indicates the vertical axis and E indicates the horizontal axis and numbers are in the Lambert coordinates. Lithology at this station is limestone and Asmari-Jahrum formations are exposed. The next table shows strike and dip of measured lineaments at this station. Figures 20 shows rosette plot of lineaments at first station. The rosette plot showing two main strikes and they are in N20°-30°E and N40°-50°E directions.

Figure 20) Rosette plot at first station.

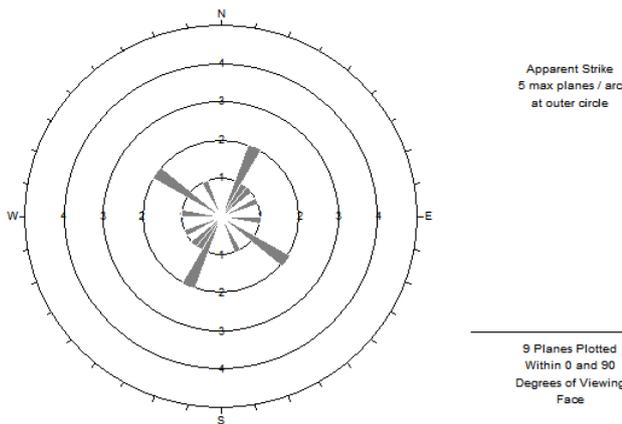
This station has coordinate E (Easting): 2298830 and N (Northing): 620330 and numbers are in the Lambert coordinates. Lithology at this station is dolomitic limestone and Asmari-Jahrum formations are exposed. Figure 21 shows rosette plot of lineaments at second station. The rosette plot shows two main strikes and they are in N20°-30°E and N50°-60°W directions.

Figure 21) Rosette plot at second station.

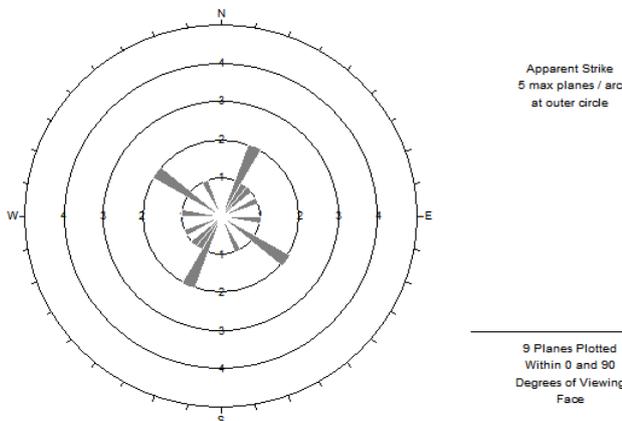
This station has coordinate E (x axis): 2317096 and N (y axis): 614600 and numbers are in the Lambert coordinates. Lithology at this station is limestone and Asmari-Jahrum formations are exposed. Figure 22 shows rosette plot of lineaments at third station. The rosette plot shows there are two main strikes and are in N0°-10°E and N60°-70°E directions.

Figure 22) Rosette plot at third station.
